# LAKE STOCKWELL DAM

## NJ 00422

### PHASE 1 INSPECTION REPORT NATIONAL DAM SAFETY PROGRAM

FEBRUARY 1980

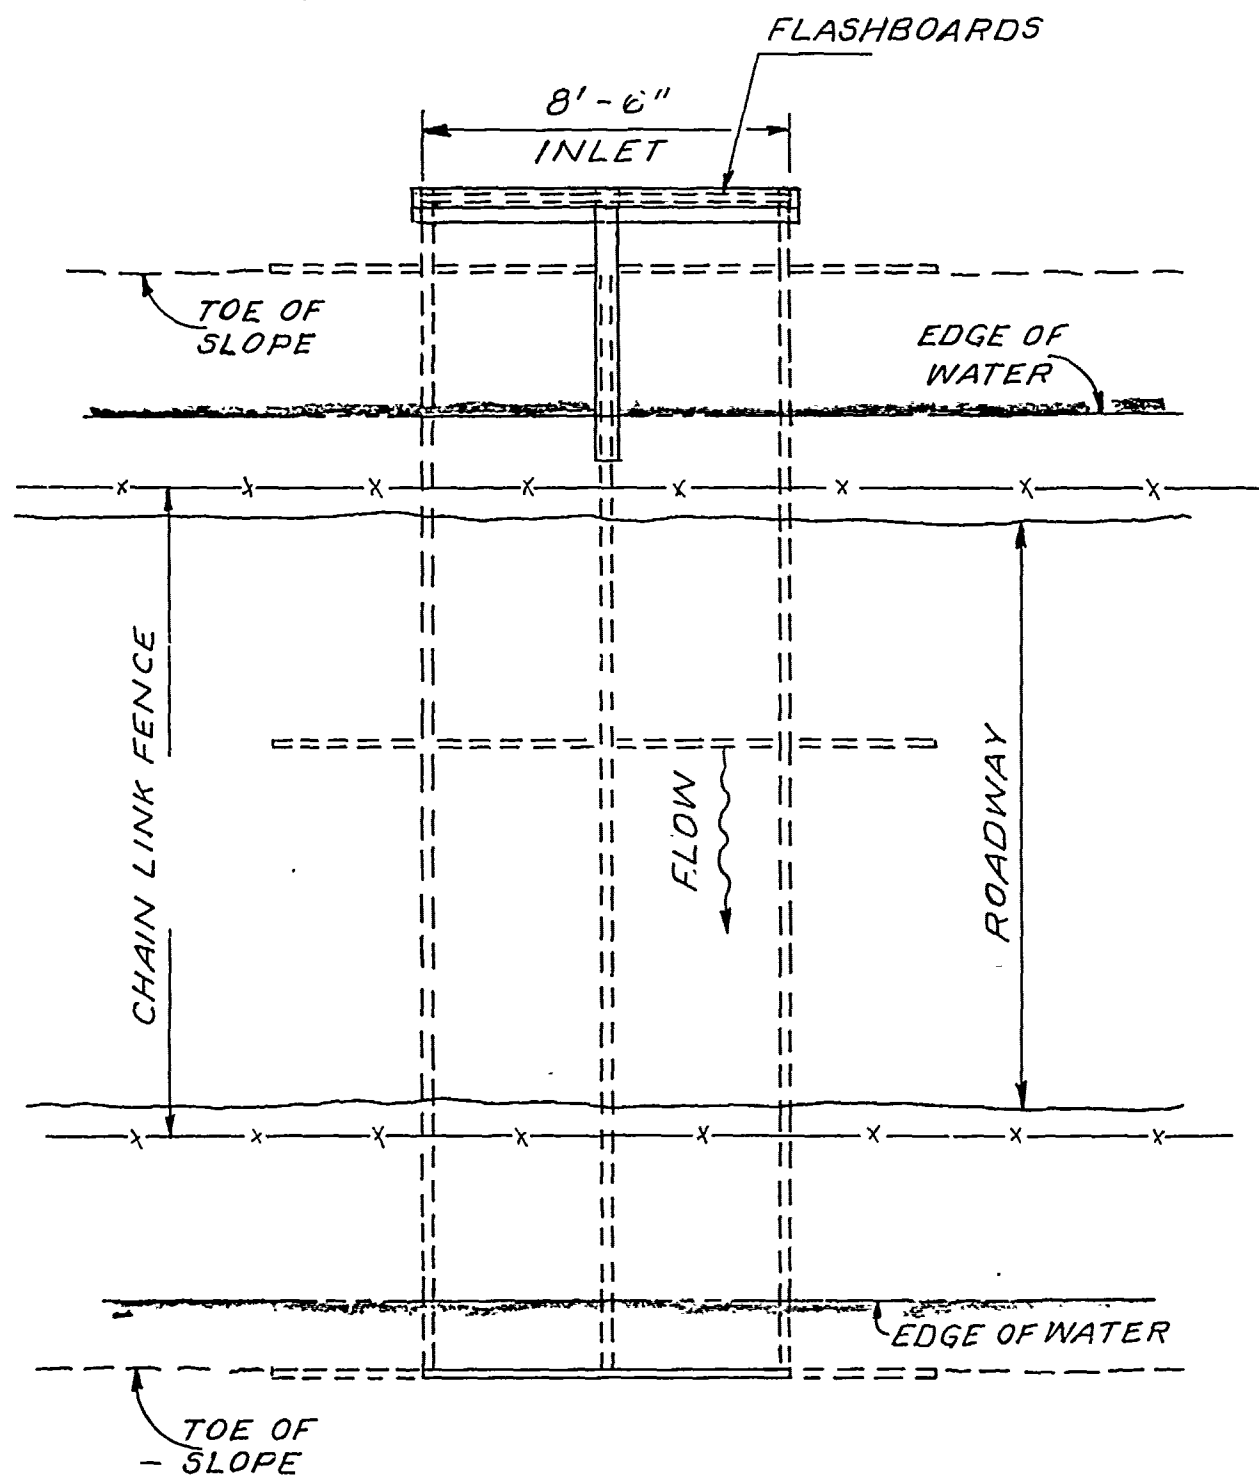
FIGURE 3

The only information available for design review were original blueprints of the 1934 spillway plan and microfilm copies of the subsequent construction dated 1947. The spillway is founded on timber piles and protected from undercutting by wood T&G sheeting on all sides. Further search of the records of the State Division of Water Resources revealed nothing on file of a technical nature. Regarding the geotechnical aspects, the dam is situated along an undulating interstream divide covered with recent silt and sand alluvium with some clay and a significant amount of organic matter near the surface. Its depth is indicated as usually in excess of ten feet. Underlying the alluvium, and existing as surficial soil beyond the stream divide is the Kirkwood Sand formation. This soil is a fine micaceous quartz sand with interbedded silty sand layers. Depth to bedrock is greater than 100 feet.

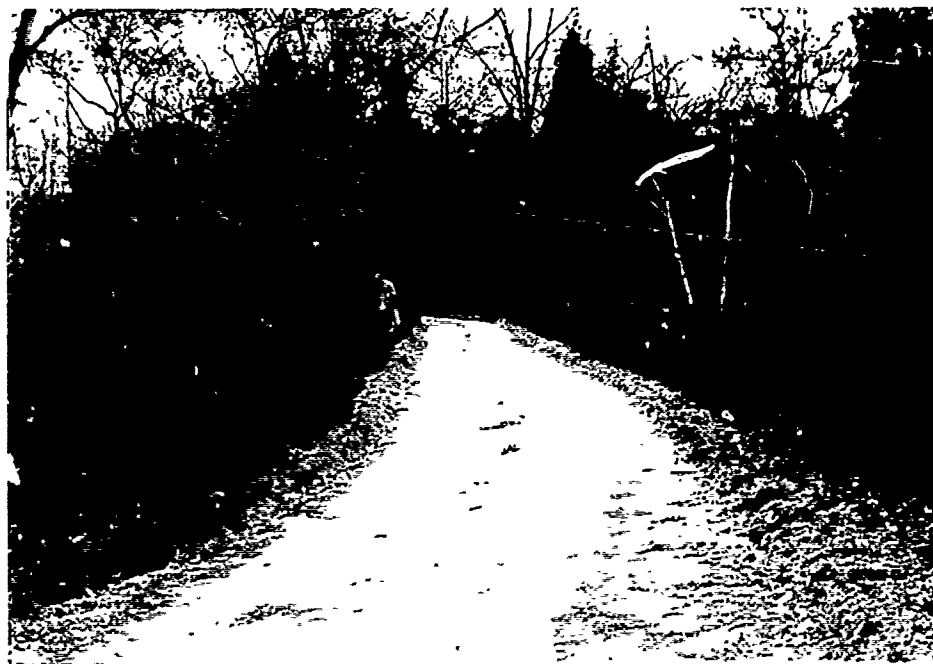
View of Crest Looking West

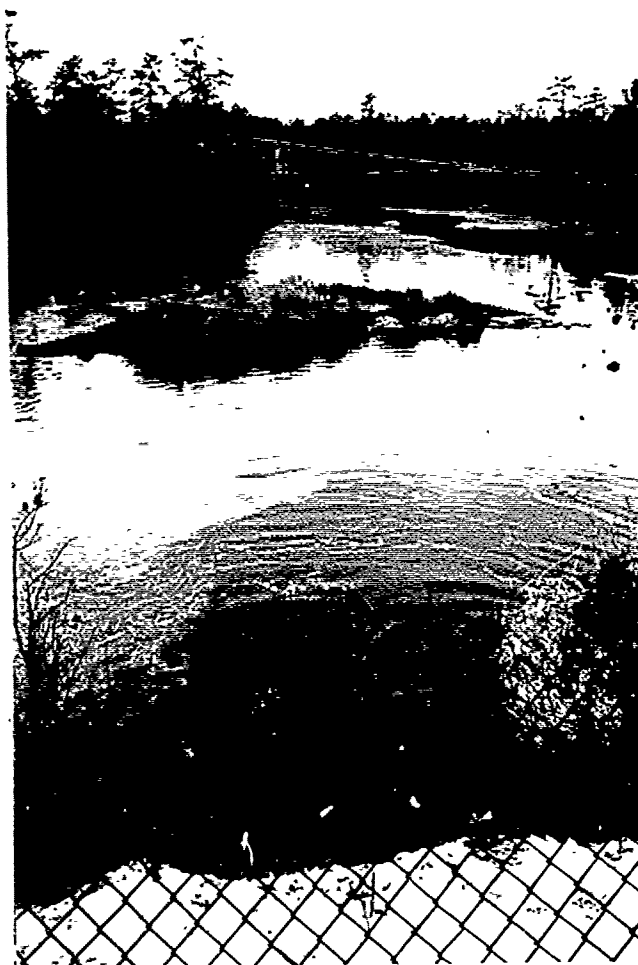
View Looking Downstream
